DIASTEMATA CORRECTION IN THE AESTHETIC ZONE BY CERAMIC VENEERS**Dr. Isha Gupta¹, Dr. Kundabala M.*² and Dr. Neeta Shetty³**¹Postgraduate student, Department of Conservative Dentistry and Endodontics,²Professor, Department of Conservative Dentistry and Endodontics,³Professor and Head, Department of Conservative Dentistry and Endodontics,Manipal College of Dental Sciences, Mangalore, Affiliated to Manipal Academy of Higher Education (MAHE),
Manipal, Mangalore, 575 001, Karnataka, India.***Corresponding Author: Dr. Kundabala M.**

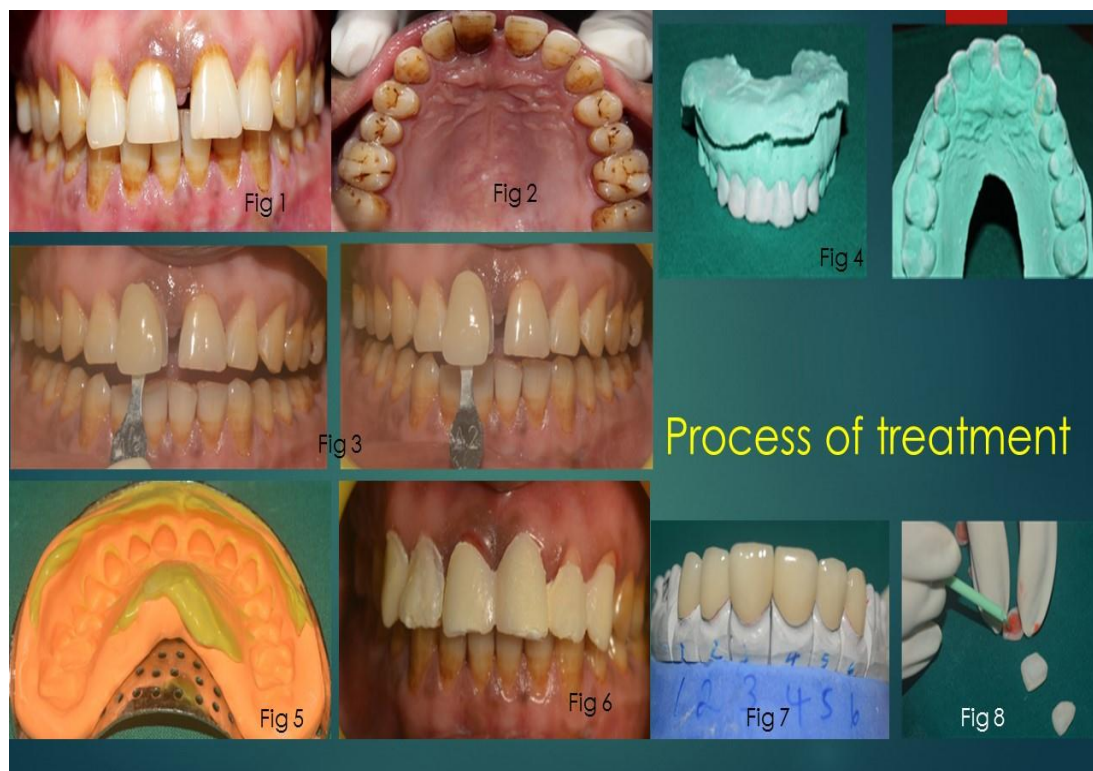
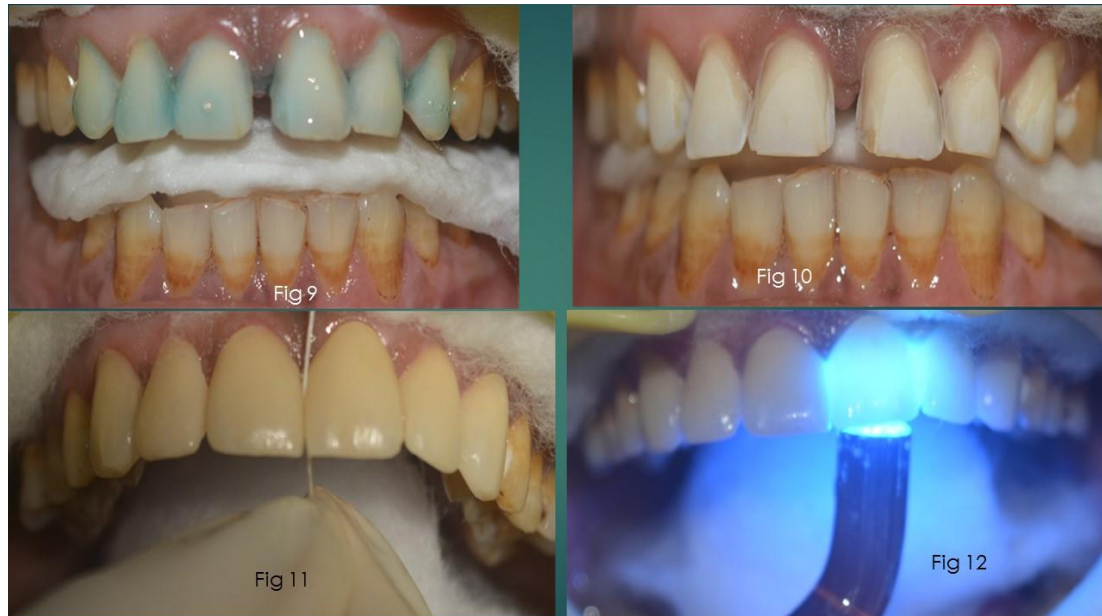
Figures: Process of treatment (Fig.1-12)

A 29 year old patient presented to the Department of Conservative Dentistry and Endodontics with the chief complaint of spacing between the upper front teeth and generalised yellowish discolouration of the teeth.(Figure 1) The patient was unhappy with the appearance of his teeth and wanted esthetic rehabilitation. The medical and family history was non contributory. Patient had the habit of smoking tobacco and chewing betel since last 7 years. Spacing was noticed between 11 and 21, 12 and 13, 22 and 23.(Figure 1&2)Yellowish brown discolouration was seen on cervical third of the crowns of both maxillary and mandibular teeth. A final diagnosis of multiple diastema in relation to upper anterior teeth

with generalized mild fluorosis and internalisation of extrinsic stains was made. Treatment options provided were orthodontic treatment for space closure followed by direct composite veneers, vital all-ceramic crowns or porcelain laminate veneers. Porcelain laminate veneers were chosen with respect to teeth no. 11, 21, 12, 22, 13 and 23 for correction of both diastema and the discolouration. Before proceeding for tooth preparation, shade was selected using Vitapan Classical shade guide. A3 shade was selected cervically and A2 for the middle and the incisal thirds. (Figure 3)

Upper and lower arch primary impressions were made with alginate and study casts were prepared. Wax mock was done on the study models to (Figure 4) modify the shape and size of the restorations with the help of a diagnostic wax. After approval from the patient, tooth preparation was done following gingival zenith correction with respect to 11.

0.5mm to 1mm of reduction was done labially using a flat end tapered diamond bur (N0 and manufacturer details). Window preparation design was carried out in all the teeth. The proximal preparation was extended beyond the contact area to labial embrasure to avoid visibility of the tooth restoration junction. The chamfer finish lines were kept at the level of gingival margin for all the teeth. All sharp angles of the preparation were rounded off and any friable enamel was removed. The stump shade was selected as A2 in both the cases.

Gingival retraction cord was placed before taking the impression. Single step double mix technique using addition silicone (manufacturer details) putty and wash impression technique was used. (Figure 5) Using the Putty index which was prepared was taken on the mock up cast used to prepare temporary restoration using Protemp (Manufacturers' details). (Figure 6).

The temporary veneers were removed. The teeth were cleaned using pumice and were dried. The ceramic veneers prepared using lithium disilicate (IPS-E max Manufacture details) were tried on to the master cast and teeth to verify color, marginal adaptation and fit. (Fig. 7) The veneers were removed from the tooth, rinsed thoroughly, and dried. Variolink N Intro Pack kit was used for the cementation according to manufacturer's instructions as follows.

The veneers were etched with 4.5% hydrofluoric acid for 20 sec and then rinsed with water. (Fig.8) A thin layer of silane coupling agent (monobond N) was applied to the internal veneer surface for 60s and air-dried.

tooth surface for 60 sec on enamel was carried out followed by thorough rinsing and air drying. (Fig.9) Bonding agent was applied. No curing was done. (Fig 10).

Variolink N base and catalyst were dispensed on a mixing pad in the ratio of 1:1. They were mixed for 10sec just prior to the application. The material was loaded on to the laminates taking care not to incorporate any air bubbles. The laminates were then gently placed one by one from mesial to distal tooth in both the quadrants with little pressure till they were completely seated till the finish line. The excess cement was removed with a sharp instrument. Tack curing was done for 2-3 seconds over the central area of the veneers. Further excess cement was removed by a sharp instrument. The teeth were flossed for the presence of any loose cement or debris. (Fig 11) Final curing was done both facially and lingually for 40 seconds respectively. (Fig.12).

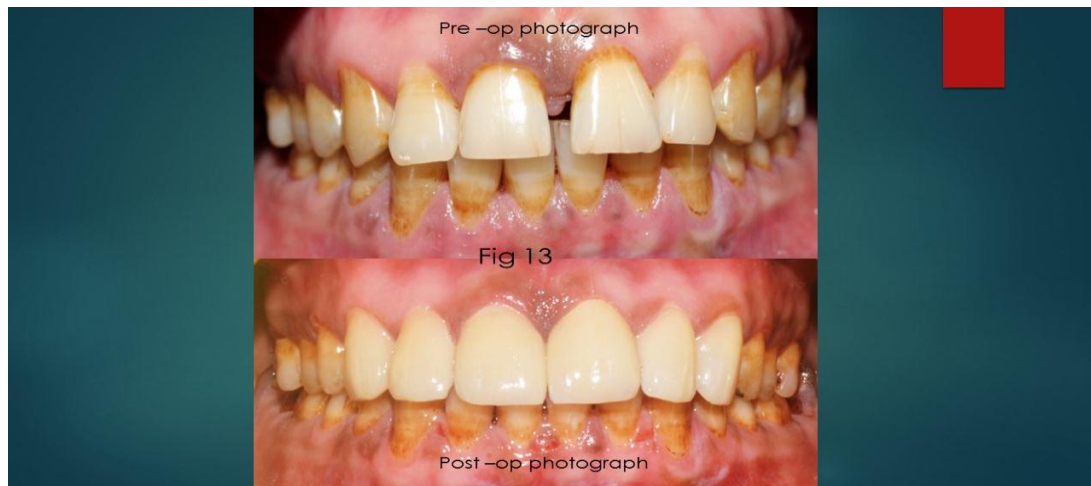
Finishing and polishing strips were applied in the proximal region. The occlusion was checked and adjustments were done. So flex was used for final polishing. Finally all the diastemas were closed with esthetic improvement of discoloured teeth was achieved with ceramic veneers. (Fig.13).

Pre and post treatment photographs.
